by Stevan Orser, D.D.S.

## Accreditation Case Report, Case Type II: One or Two Indirect Restorations

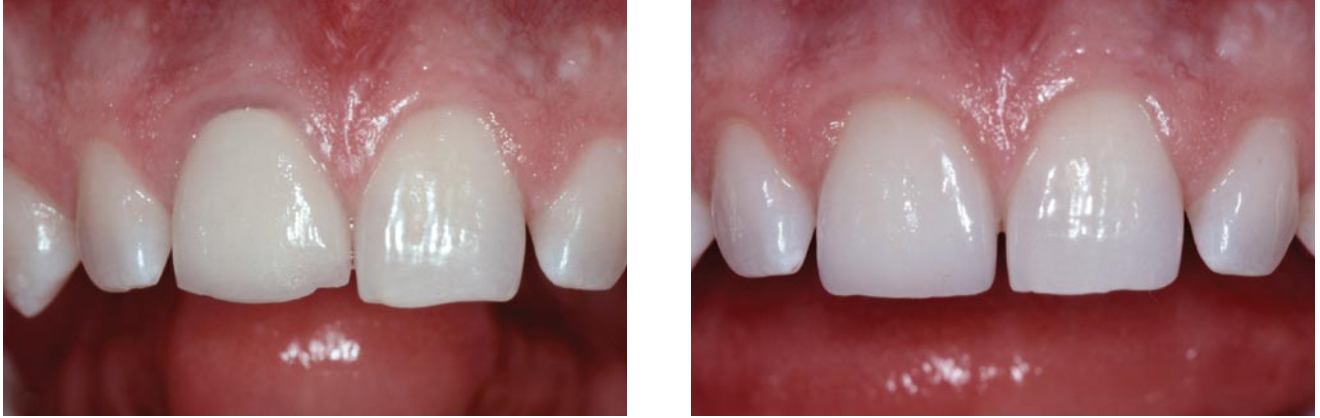
*Figure 1: Retracted 1:1 view of the new crown. It replaced the chipped and dark crown done years earlier after endodontic therapy.*

The use of color maps, prototype provisionals, and photography has emerged to help communicate details. By mimicking the microesthetics of a natural tooth, the ceramist can reproduce the minute details of surface textures and color patterns that are present in the surrounding natural teeth.<sup>1,2</sup> (Fig 1).

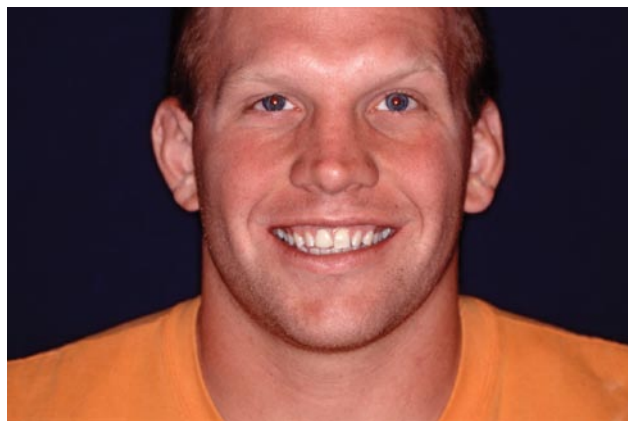
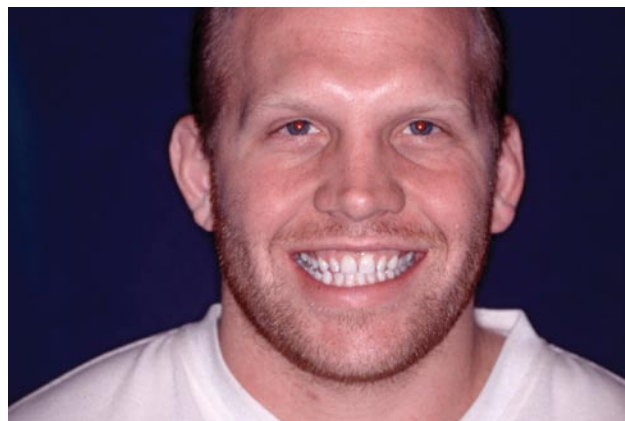
Figure 2: Full-face 1:10 view. Note how distracting the old crown is.

The patient was a 23-year-old male in excellent health. Ten years earlier he had injured his front tooth during a wrestling meet. Because there was pulpal damage, root canal therapy was completed for tooth #8 at that time. Shortly after, a porcelain-fused-to-metal (PFM) crown was placed to restore the tooth. The tooth had been stable and comfortable for many years (Fig 2).

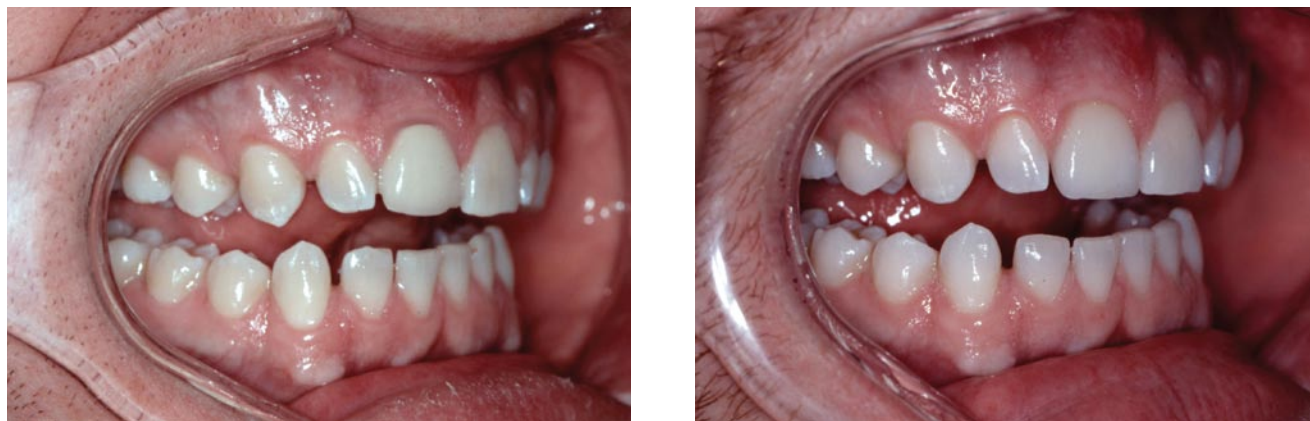
Figure 3: Retracted 1:2 view of the old crown, revealing the dark margin and contours needed to match the other central.

The tooth color ranged from A2 to A3, with spaces between the anteriors. Some chipping was evident on both the lower and upper front teeth. The patient revealed a moderate amount of gingiva when he smiled. Considering the dark margin around the crown and these other defects, he felt it was time to replace the old restoration (Fig 3).

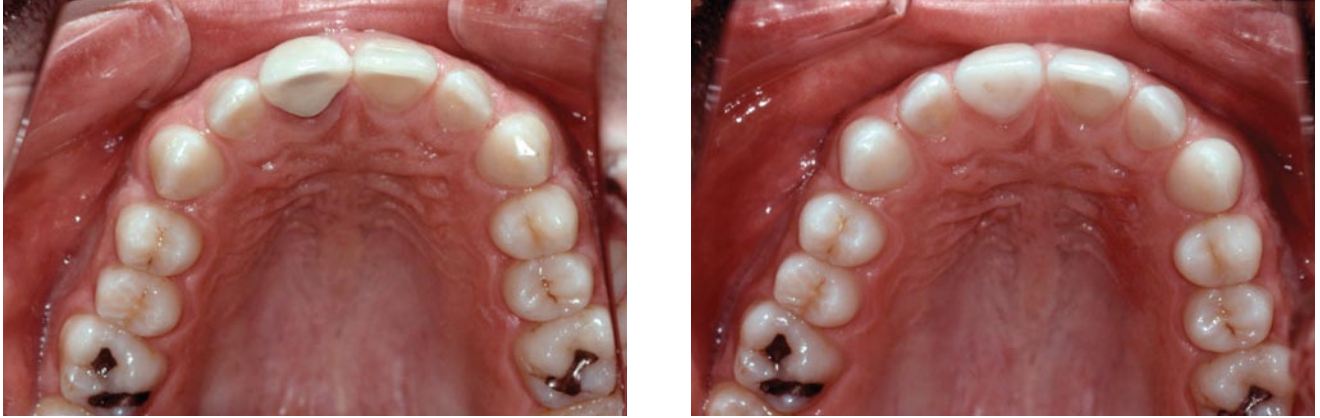
Figure 4: Occlusal 1:2 view. The lingual contours of the new crown are designed to meet the "two point rule" for protusive guidance.

movements. Protrusive guidance on both centrals was adjusted for balance (Fig 4). Metal FlexiStrips were used to clean the interproximal. It was then checked with fine floss for smoothness. The patient was given oral hygiene instructions following bonding and recommended to not chew for four to six hours. At follow-up he looked good and reported the bite felt comfortable. We recommended hygiene maintenance to keep the tissues healthy. After eight weeks he returned for photographs and x-rays (Fig 5). We then completed the finishes on the composite and any final contouring required.

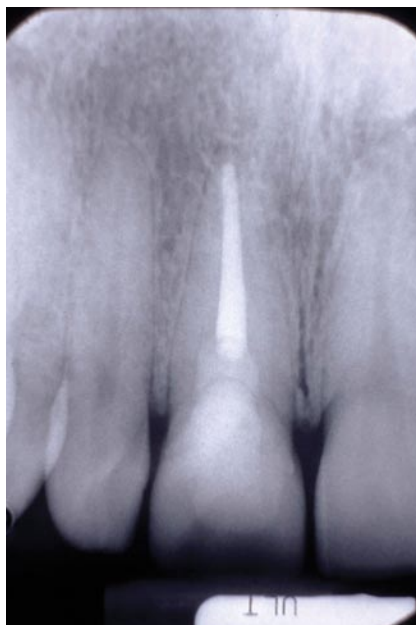
*Figure 5: Postoperative radiograph, two months after the new restoration was placed.*

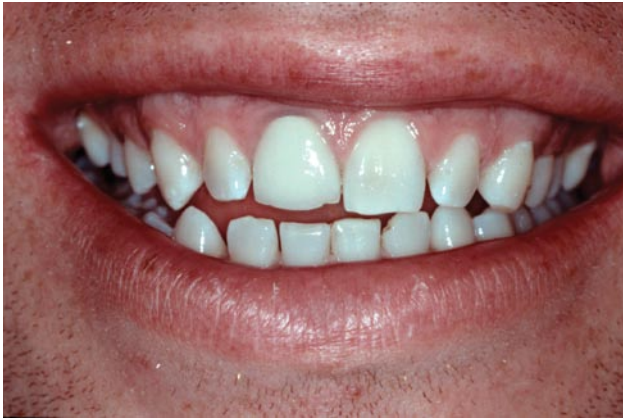
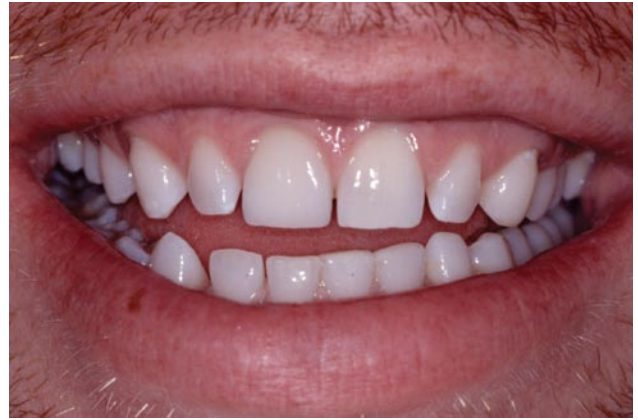
Figure 6: Straight smile view of the old and the new restoration, showing the improved color and contours.

The patient was quite pleased with the result (Fig 6). Since he no longer wrestles, we hope the risks to his front teeth are reduced. He has
