ACCREDITATION ESSENTIALS

Accreditation Clinical Case Report, Case Type IV: *Class IV Direct Resin Restoration (Teeth ##7 and 8)*

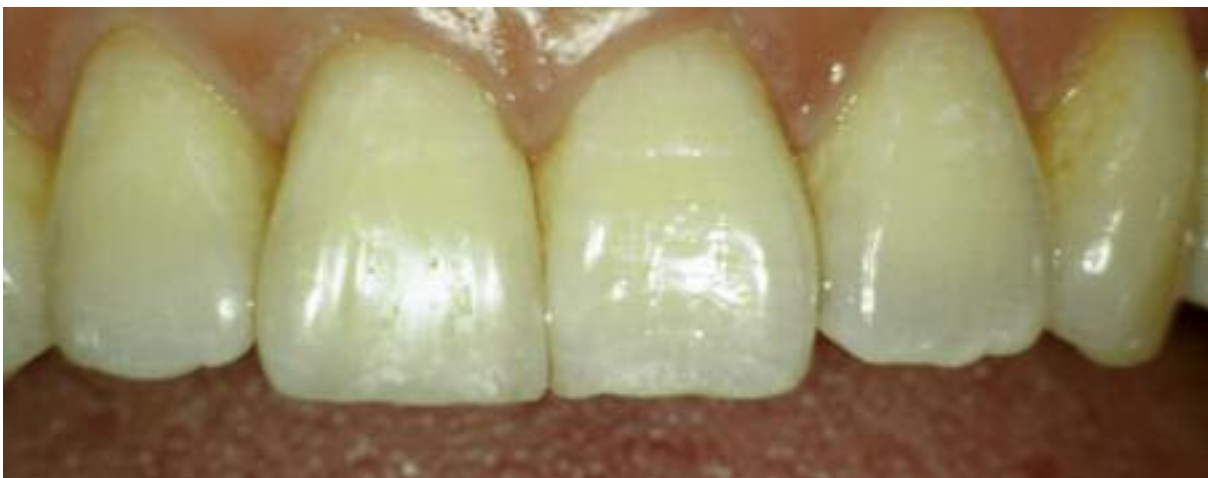
Figure 4: Frontal view, 1:1 retracted view, after.

- The contour and margin on the mesial of #8 did not replicate the original tooth structure. The "before" photographs provide a perfect model for emergence profile, facial embrasure, incisal embrasure, and line angle. The puffy and blunted papilla between the centrals may result from the ledging of the resin at the mesio-gingival of #8. The tissue health was considered a minor fault.
